# Manhole Inspection Summary

## Manhole # S13S\_\_017MH

Insp Date: **3/12/08 9:15 AM**

**Location** Address: **915 Wilmington Ave**

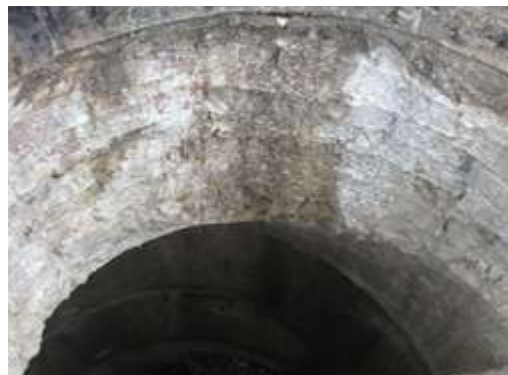
Defect 1

☒ **Leaks**

frame-lid infiltration

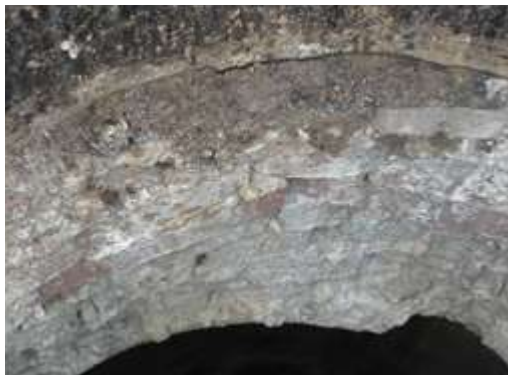
Defect 2

Offset: **1.5** (in.)

Offset

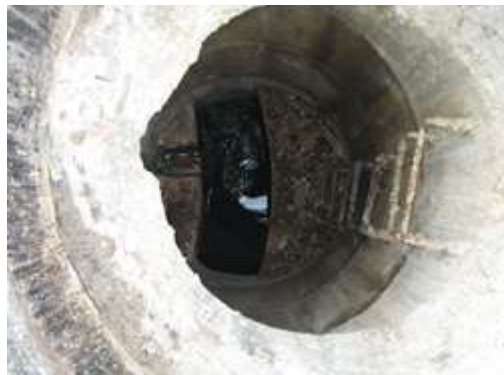
defect 3

☒ **Corroded**

corroded steps

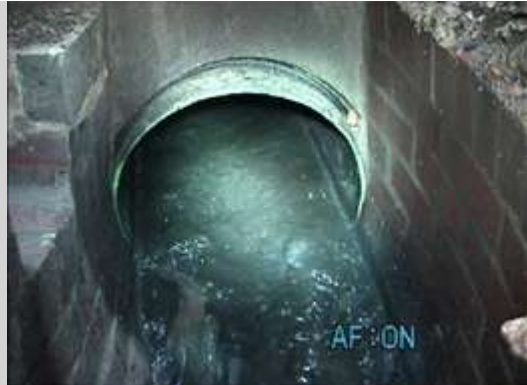
12 O'Clock Outflow

18 in. Circular Gravity Sewer  
Pipe Out @ 12 O'Clock

Pipe Height: **18** (in.) Rod and Bar (Angled)  
Pipe Material: **PVC** ☐ Pipe Lined  
Invert Depth: **11.46** (ft.) Flow Characteristics: **Slow**  
Deposits: ☒ None ☐ Mud ☐ Sludge ☐ Debris ☐ Grease  
Silt Depth: **0** (in.) Deposits Extent:  
Infiltration: **None** Pipe Seal Cond: **Sound**

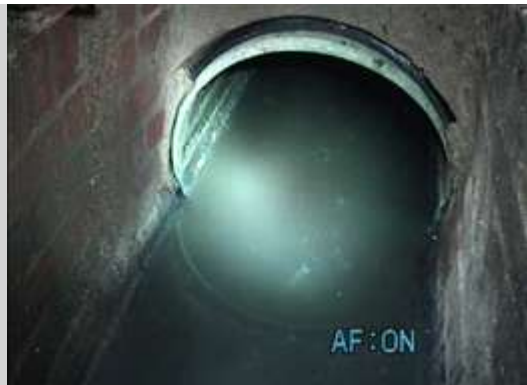
7 O'Clock Inflow

18 in. Circular Gravity Sewer  
Pipe In @ 7 O'Clock

Pipe Height: **18** (in.) Rod and Bar (Angled)  
Pipe Material: **PVC** ☐ Pipe Lined  
Invert Depth: **11.34** (ft.) Flow Characteristics: **Slow**  
Deposits: ☒ None ☐ Mud ☐ Sludge ☐ Debris ☐ Grease  
Silt Depth: **0** (in.) Deposits Extent:  
Infiltration: **None** Pipe Seal Cond: **Sound**

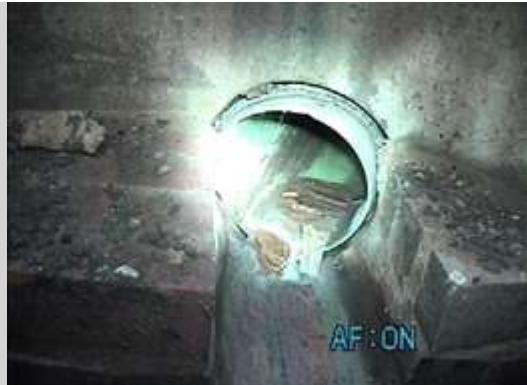
10 O'Clock Inflow

8 in. Circular Gravity Sewer

Pipe In @ 10 O'Clock

Pipe Height: **8.4** (in.) Rod and Bar (Angled)

Infiltration: **None**

Pipe Seal Cond: **Sound**
